FIELD INSPECTION

Project Name:	Mountain Valley Pipeline	Inspector:	Matthew Grant
Inspection Date:	Tuesday, May 7, 2019	Project Contact:	Brian Clauto
Spread: Pittsylvania County MP285.8-284.9	Spread I	Weather (Wet/Dry/Rain):	Dry

FIELD INSPECTION PHOTO LOG

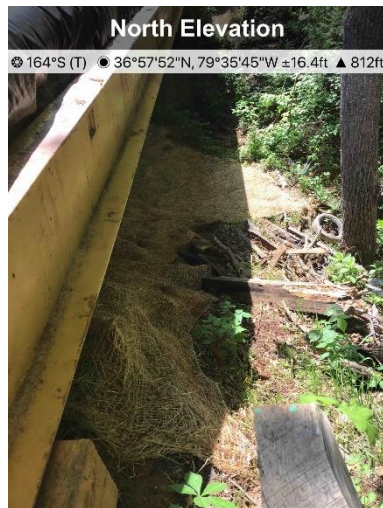
- Fig. 1 GAS-D1-EPH has had bank repair conducted per previous inspection dated 3/6/19.

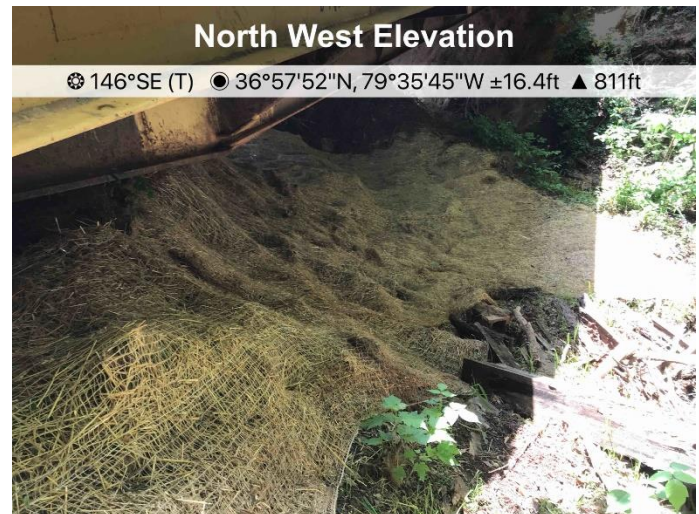
- Fig. 2 GAS-D1-EPH has had bank repair conducted per previous inspection dated 3/6/19.

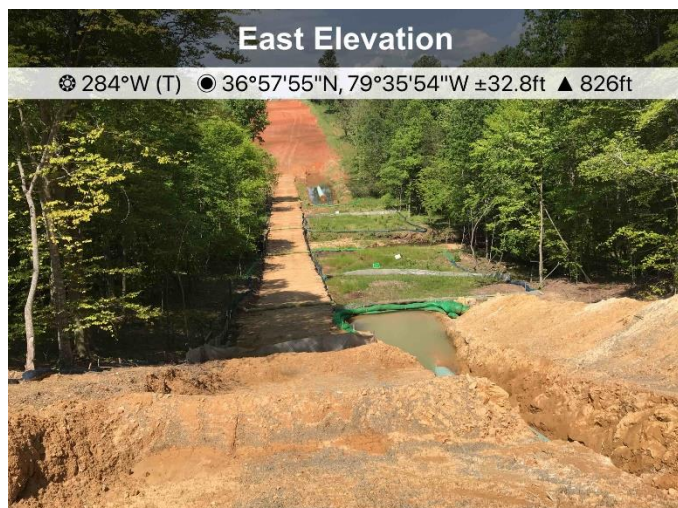
- Fig. 3 Above designated stream S-D2 and wetland W-D3, ECD's are in place and functioning.
